INDOOR AIR QUALITY ASSESSMENT

**Department of Public Works
Customer Service Center and Garage
76 East Worcester Street
Worcester, Massachusetts**

Prepared by:
Massachusetts Department of Public Health
Bureau of Environmental Health
Indoor Air Quality Program
October 2017

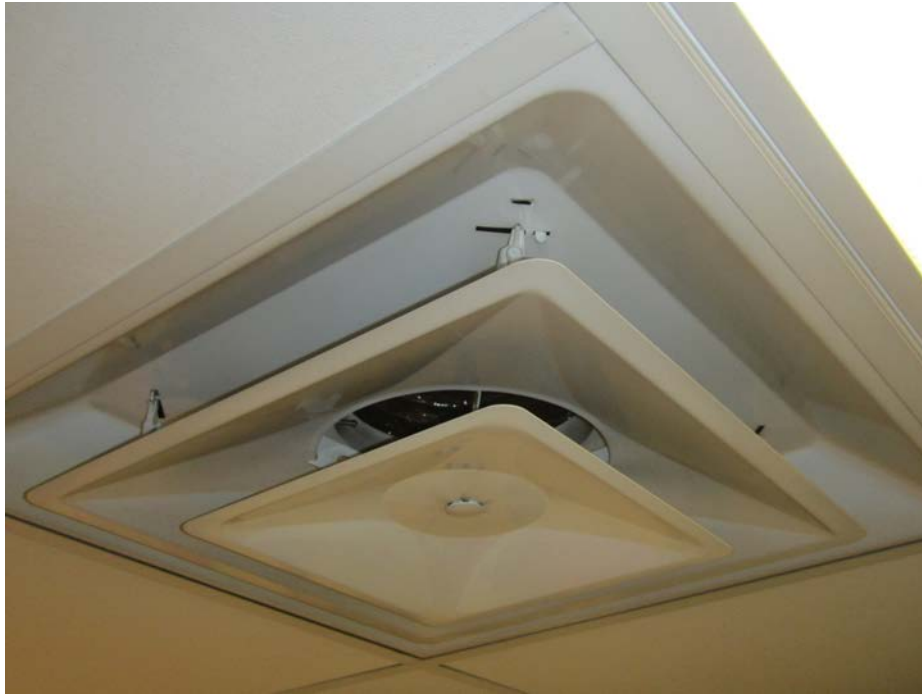
Picture 1

Supply air diffuser

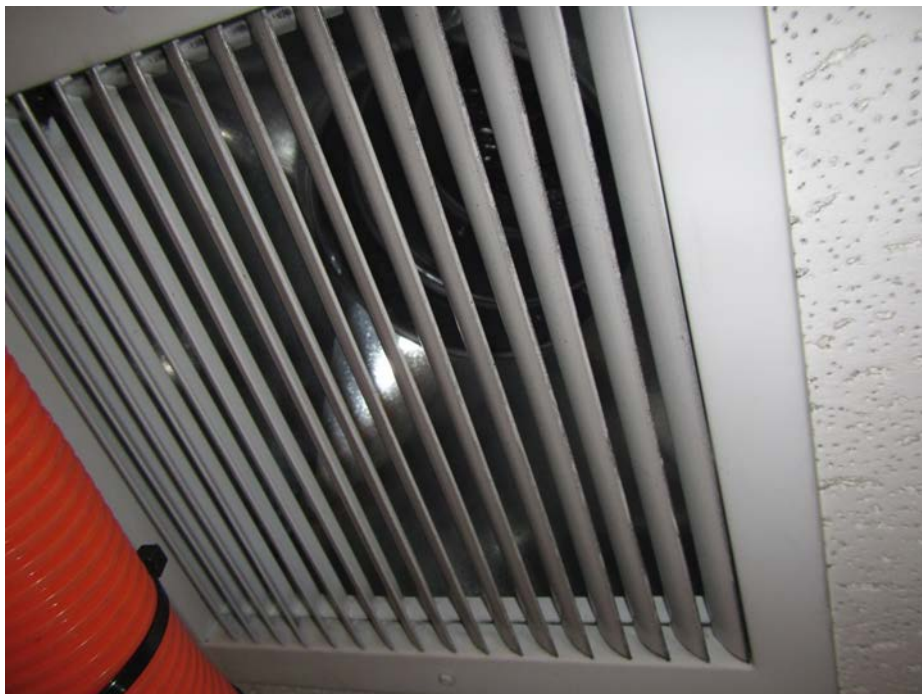
Picture 2

Return air grate

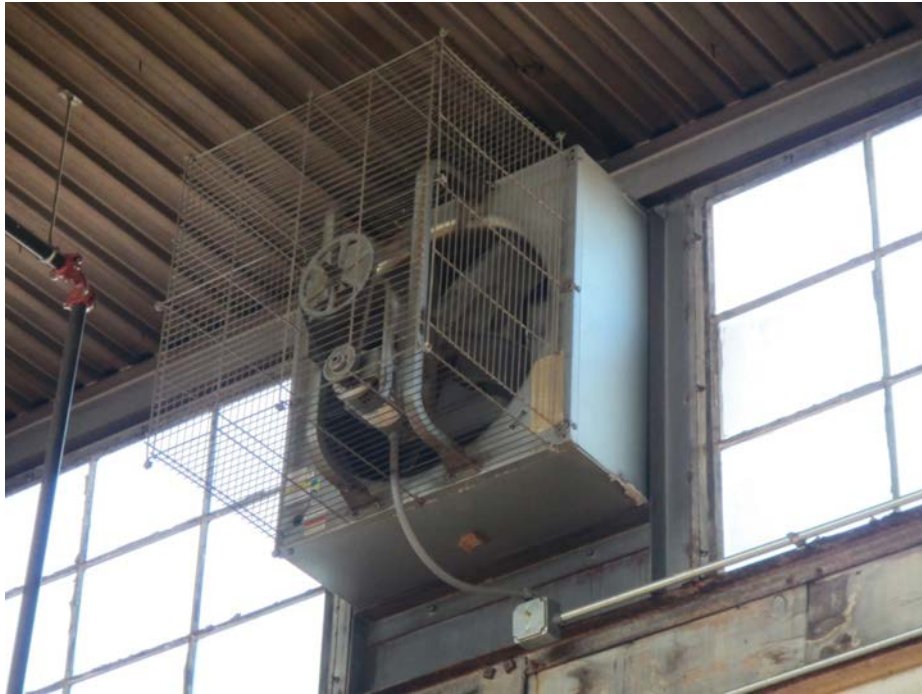
Picture 3

The main garage area has several general exhaust fans (Picture 3) that are operated on an as-needed basis. There are make-up air supply ducts with louvred doors (Picture 4) to introduce fresh air during the operation of the exhaust fans. It was reported that DPW staff typically leave the garage doors open to further increase air circulation.

General exhaust fan in DPW garage

1. Continue to refrain from idling vehicles in the garage.
2. Utilize existing general exhaust ventilation whenever combustion-related activities are performed (e.g., vehicle emissions, welding, etc.).

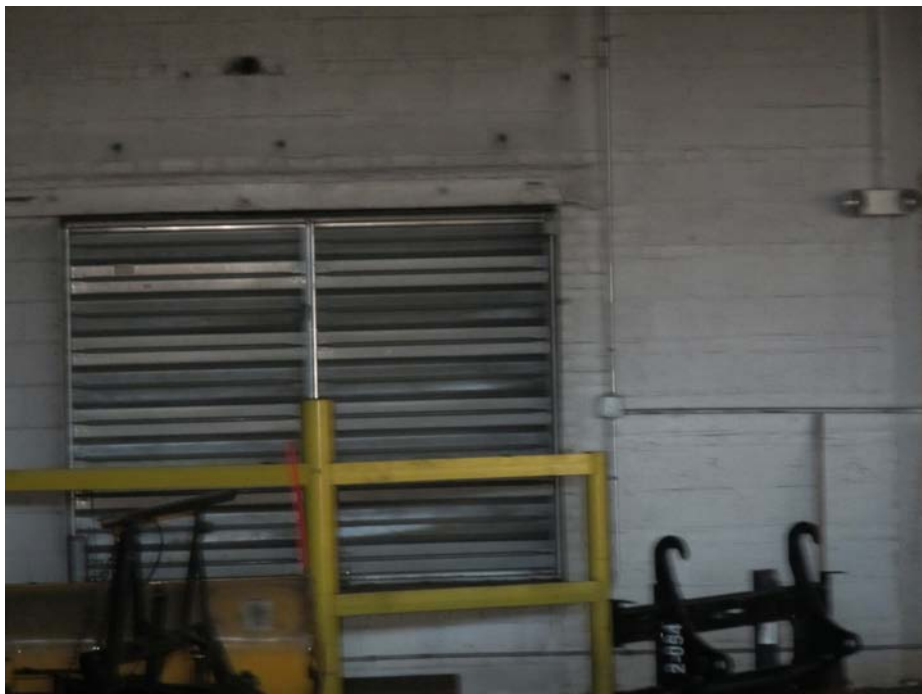
Picture 4

Make-up supply air vent

3. Ensure adequate make-up air supply during the use of ventilation systems to effectively clear and eject products of combustion from the garage bays.

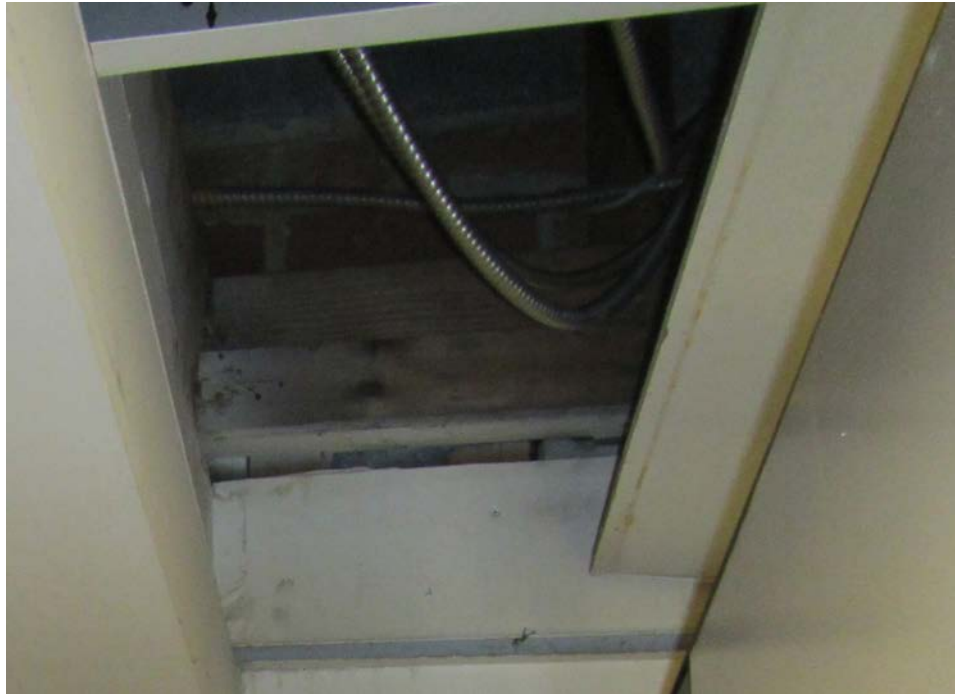
Picture 5

IAQ staff noted some pathways for vehicle exhaust and other pollutants (e.g. moisture, odors) to move from garage bays and unconditioned areas into adjacent office areas. Missing ceiling tiles and gaps around utilities were noted in the server room (Pictures 5 and 6). Further investigation of this separation wall should be conducted especially in areas above the ceiling tiles. If further pathways are found they should be properly sealed. As recommended by IAQ staff, the main door separating the garage and office area is reportedly kept closed (Picture 7). This door should be periodically inspected to ensure that weather stripping and door sweeps are intact so that no light is visible around the door edges.

Missing ceiling tile in server room may serve as a pathway

5. Replace missing ceiling tiles and seal any other gaps or breaches in the shared walls and ceilings between occupant areas and garage bays to avoid the intrusion of particulate matter, odors, and water vapor into occupied areas.

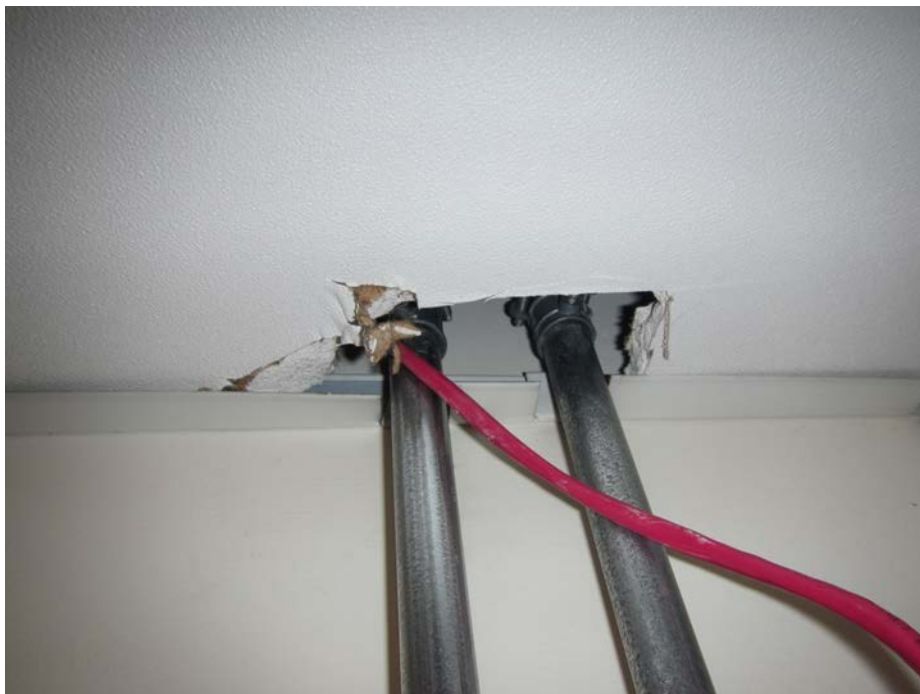
Picture 6

Gaps around utilities in server room

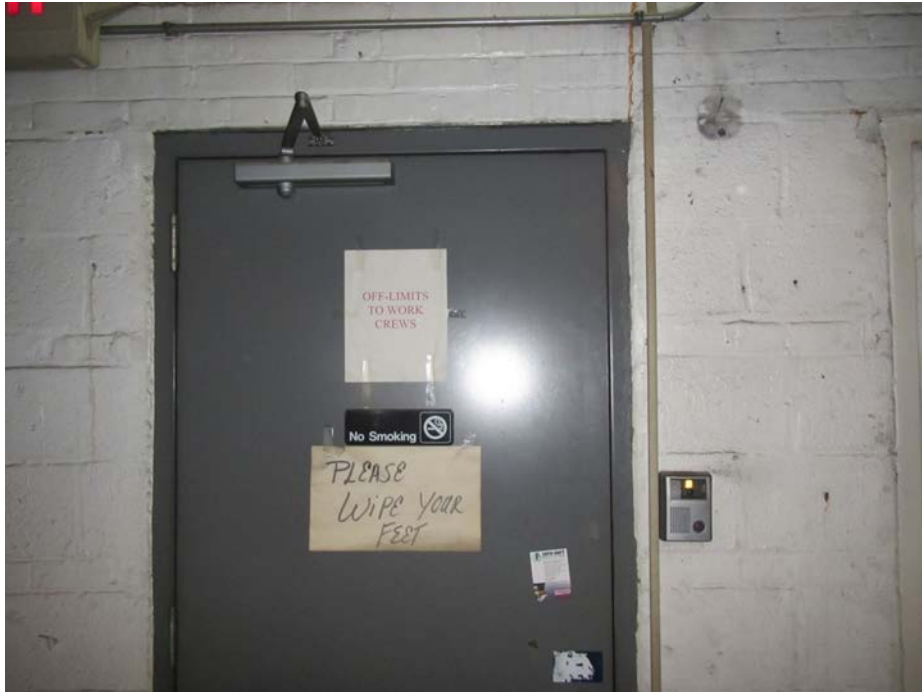
Picture 7

Door leading from garage to office kept closed

4. Continue to keep doors that separate garage bays from office areas closed. To prevent products of combustion from entering these occupant areas, maintain weather stripping and door sweeps as needed so that no light is visible beneath or around the doors.

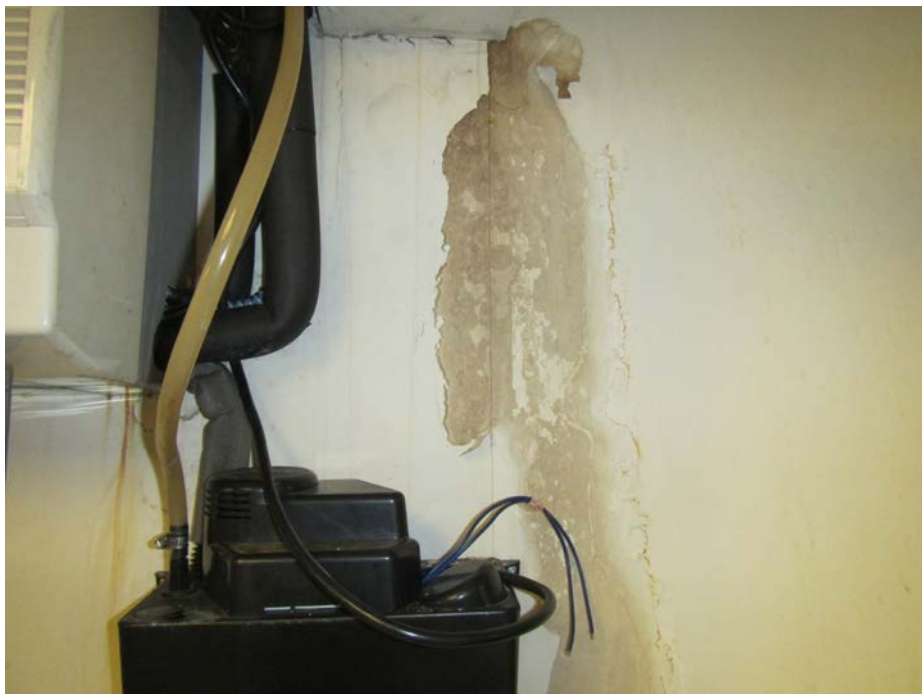
Picture 8

IAQ staff identified multiple areas in the CSC office area with water-damaged materials. The server room had the most extensive water damage reportedly, from the water leak at the intersection of the garage/office roof levels (Pictures 8 to 10). DPW staff reported that this leak has since been repaired. This room has a ductless air conditioning unit which appeared to have an accumulation of debris in the supply vents (Picture 11). These units should be regularly cleaned to prevent debris from serving as a substrate for mold colonization should condensation occur. They should also be monitored to ensure that condensation generated is properly drained and not a source of moisture to the server room.

Water-damaged gypsum wallboard in server room

6. Water-damaged gypsum wall board, ceiling tiles, paper-backed insulation, and carpeting should be removed in a manner consistent with the EPA guideline “Mold Remediation in Schools and Commercial Buildings” (USEPA, 2008).

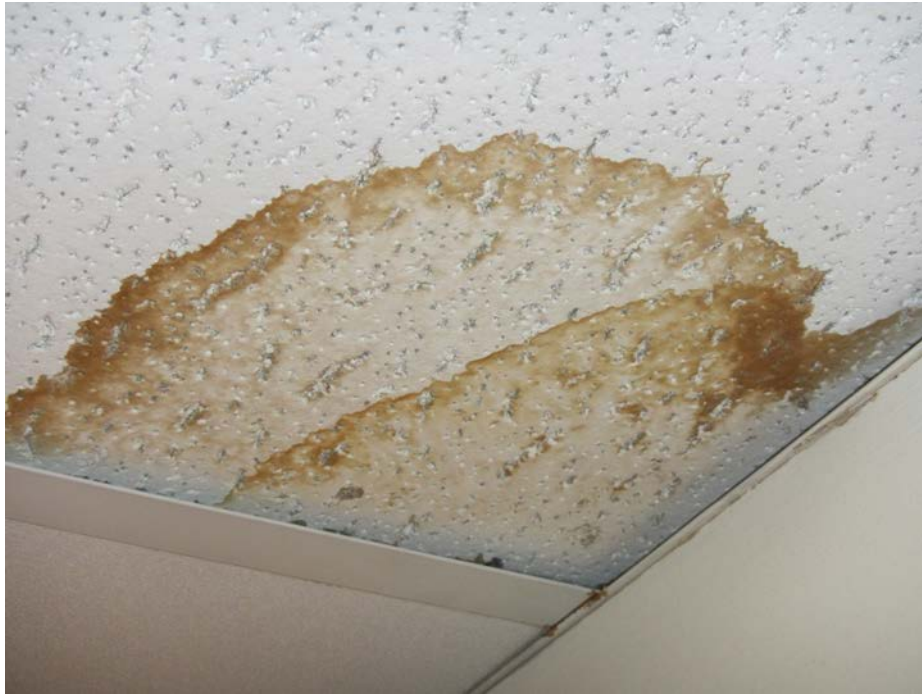
Picture 9

Water-damaged ceiling tile in server room

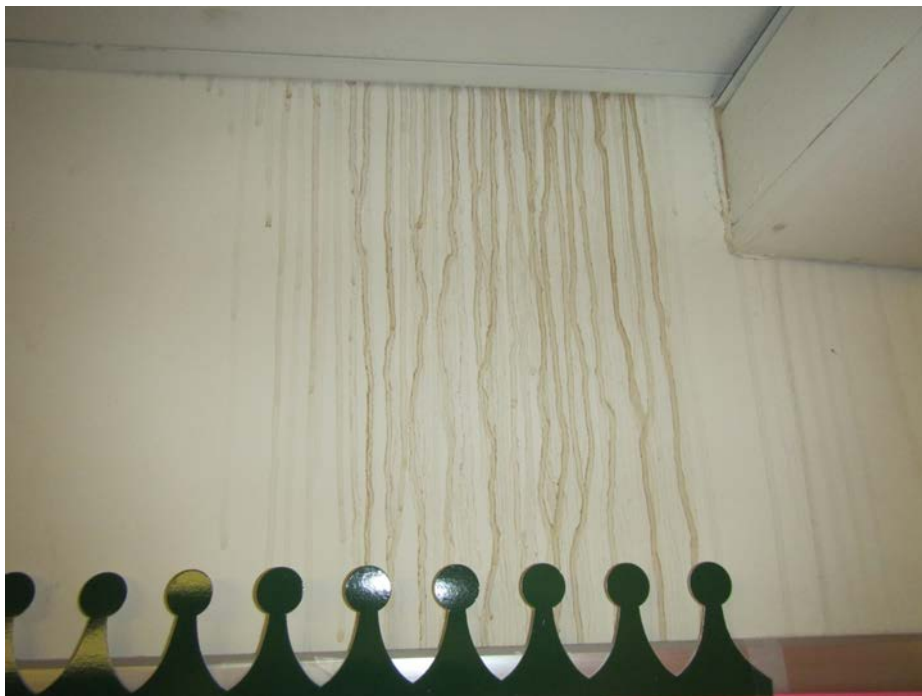
Picture 10

Water-damaged gypsum wall board in server room

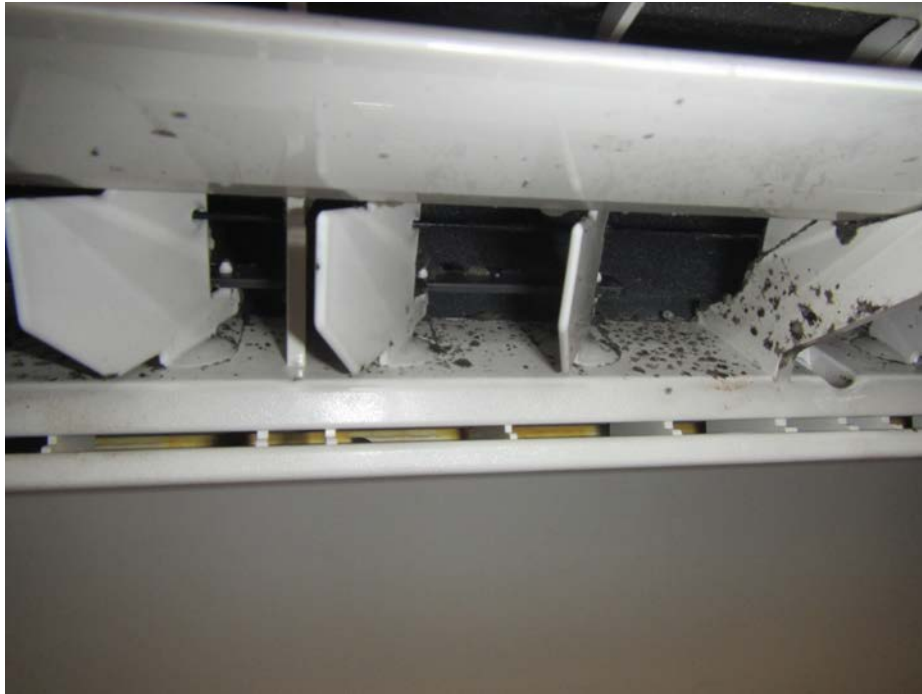
Picture 11

Air conditioning unit vent with debris accumulation in server room

12. Regularly clean the ductless air conditioning unit according to manufacturer recommendations to prevent the accumulation of debris. Ensure proper drainage of condensate from the unit.

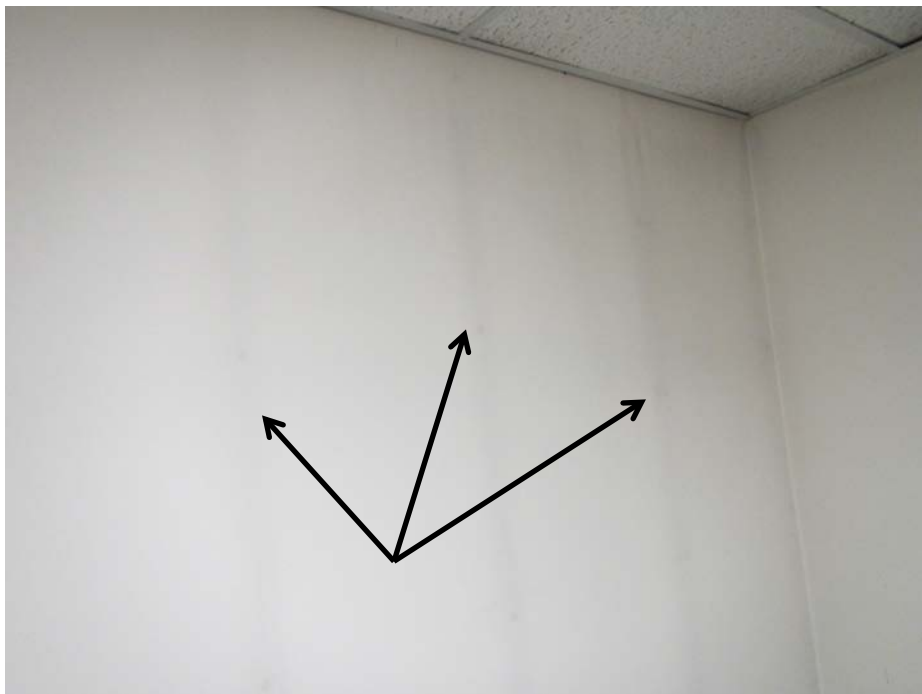
Picture 12

The CSC office area also had several walls in other areas which appeared to have a “ghosting” effect. The wall studs and nails were visibly stained at the surface of the gypsum wallboard (Pictures 12 and 13). The walls affected were primarily exterior walls located on the south side of the CSC (facing railroad tracks) and the interior walls which abut the garage. A small area of gypsum wallboard was also impacted in this manner in the break room near the refrigerator.

This ghosting effect is typically the result of either small particulate (e.g., soot) accumulation on surfaces of opposing electrical charge, or chronic moisture and microbial growth. Small particulates may result from an improperly functioning and vented furnace, or from indoor sources such as burning candles, which may emit both particulates and potentially irritating fragrances. It may also be accumulation of particles from vehicle exhaust from the garage area that have entered through pathways such as those described above. If the dark streaks are wiped with a wet towel and appear to smear on the surface then they are most likely the result of particulate accumulation. This can be cleaned to remove the streaking.

“Ghosting” effect observed on walls in the CSC area

7. Determine if the “ghosting” effect noted on the CSC walls is the result of surface soot accumulation or chronic moisture. Clean walls with mild detergent if soot/particulate accumulation is noted.

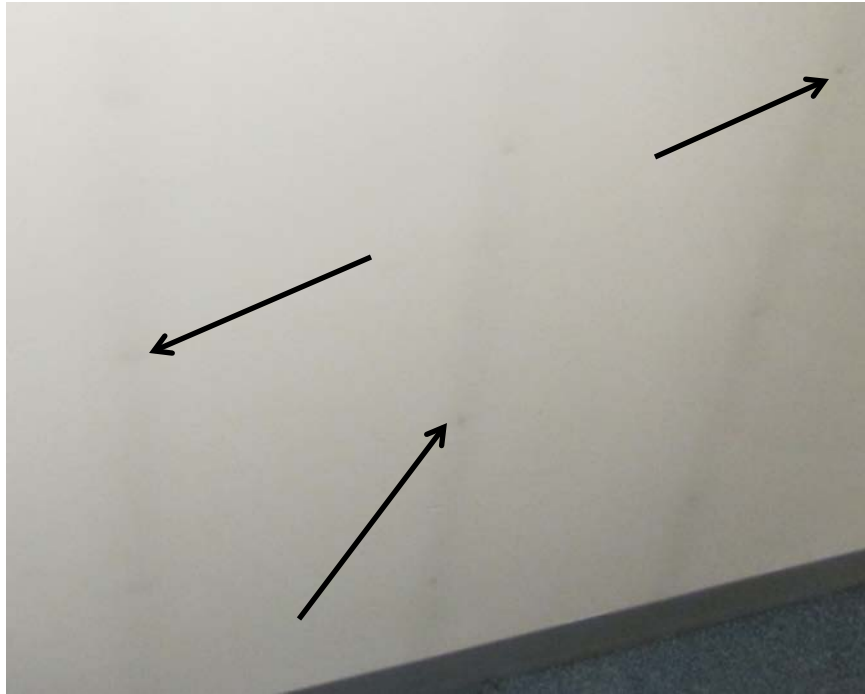
Picture 13

“Ghosting” effect on walls (note outline of studs and nails)

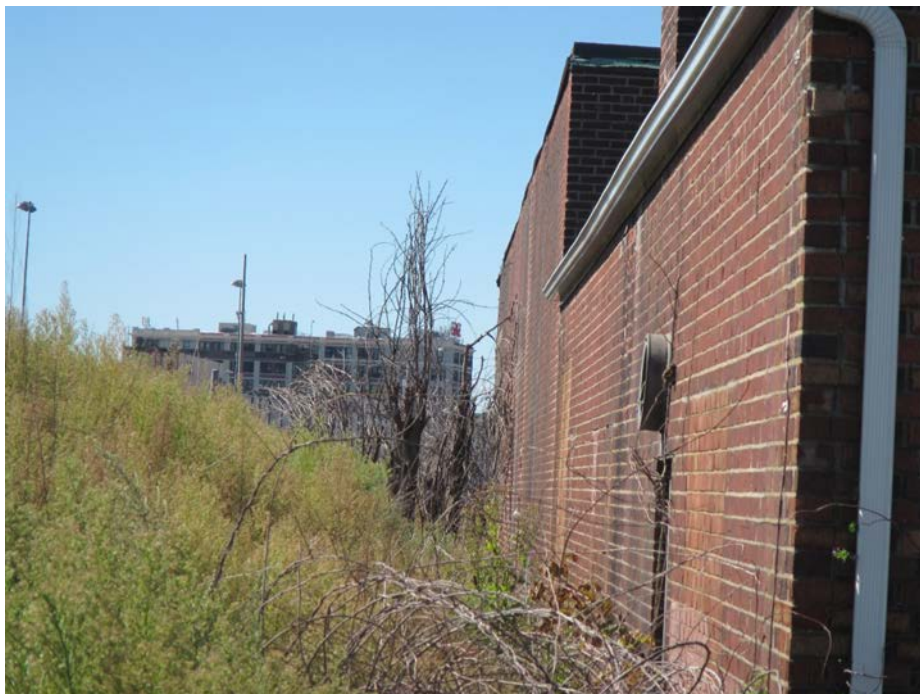
Picture 14

There may be several factors contributing to chronic moisture at the CSC. As mentioned, the recently repaired roof leak at the intersection likely contributed to the significant water damage in the server room. The grading of the slope leading from the railroad tracks may be directing water towards the southern exterior brick wall. This location is also overgrown with vegetation and will hold moisture against the brickwork (Picture 14). Brick and mortar walls are not water-tight but typically have a drainage plane with a water-proof membrane behind the brick wall and functioning weep holes to allow drainage from the base of the brick (Figure 1). Also, before gypsum wall board is installed, insulation and a vapor barrier is generally required to resist accumulated moisture and condensation due to water vapor from penetrating into the wall board. IAQ staff have observed many different buildings where this is either not present or not installed correctly. This can not be verified without opening up walls to inspect for proper vapor barrier installation but may be contributing factor. The moisture content of these walls were checked with a moisture meter and found to be dry at the time of this assessment.

Grading from railroad tracks down to exterior of building (note overgrown vegetation)

9. Inspect the south-facing exterior perimeter for proper drainage. If necessary, install perimeter drainage to direct stormwater down and *away* from the building foundation/brick wall.

14. Trim or remove any vegetation within 5 feet of the building exterior to reduce moisture against building envelope.
15. Continue to store porous materials (e.g., cardboard boxes, paper items) on pallets or shelving to prevent water damage. Discard any existing water-damaged porous materials.
